1607 S. Dakota Ave. • Sioux Falls, SD 57105 Doug (605) 201-6116 • Don (605) 366-2163

Member InterNACHI - International Association of Certified Home Inspectors

Client:	Property Location:	- N- of 12 (12)			
Address:		Sioux Falls, SD			
City:		57105			
State, Zip:					
Date of inspection: Jun 24, 2016 Time: 8:00 am	Weather conditions: Sunny	Outside temperature:	66	٥F

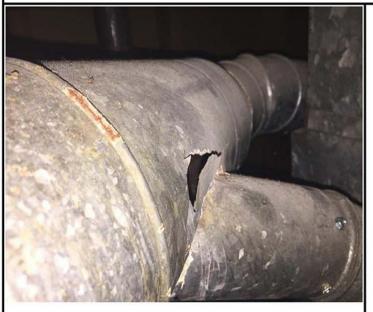
There are moisture stains, rust and an opening at the furnace/water heater chimneys. The furnace/water heater chimney may not have proper clearance where they pass thru the floor joist, (all visible from the lower level) Due to the age of the furnace and the condition of the chimneys we recommend having the furnace, chimneys and heat exchanger cleaned, serviced, and evaluated by a professional HVAC contractor before closing.

Image information: Opening in the furnace/water heater chimney.

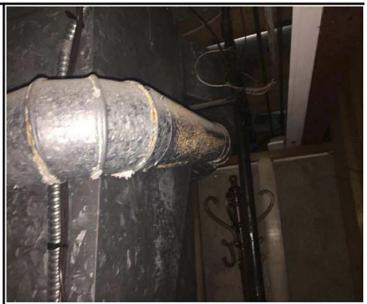
Image information: Rusting and moisture stains on the furnace chimney.
